## PHILIPPINE CENTER for WATER and SANITATION

### IRON REMOVAL FILTER

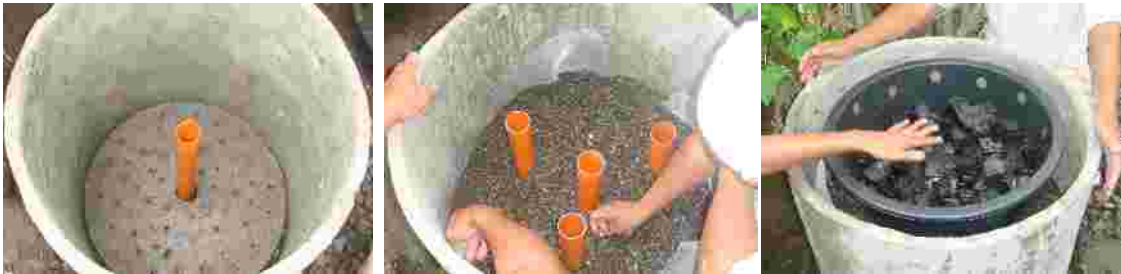
The iron removal filter (IRF) is a cylinder built using ferro-cement construction techniques. Inside, in top to bottom order is a plastic basin full of charcoal, a layer of gravel and an empty space for sedimentation. The water to be treated (in this model the water is assumed to be from a hand pump spout) first passes through the charcoal, aerating it, flows to the empty space at the bottom via a pipe where sedimentation of the precipitated iron takes place, then wells up through the gravel for filtration purposes. The finished water accumulates above the gravel filter, and this elevation enables users to draw it.

Engineers of the Philippine Center for Water and Sanitation (PCWS) teach communities how to construct iron removal filters.

To use it for the first time, the filter is filled with water and allowed to overflow a little. The first discharge is turbid from the gravel, but this clears up after a day or so of use. After placing their buckets under the tap, the users just pump the hand pump, and by gravity the water enters and flows through the filter, displacing the previous treated contents, which then overflows thru the taps into their buckets.

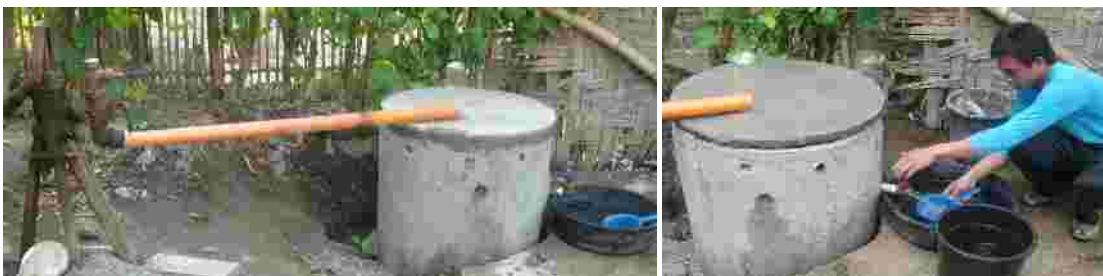
The gravel may also eventually clog up occasionally. Cleaning it is also by manual agitation while recycling water through the IRF. A bucket is placed under the open tap and the contents rilled by pouring dipper by dipper back through the charcoal basin. In c where deposits have built up in the sedimentation space, a drain can be opened to clean this out. The worst that can happen is that the unit may eventually need overhauling. All parts are then taken out and cleaned, and clogs and leaks repaired.

It is possible that the charcoal may eventually clog up. The basin can then be removed from the IRF and cleaned by running water through it, assisting the process by manual agitation of the charcoal chunks.
